GUIDE
FOR
SELECTING ROUGHNESS COEFFICIENT
"n" VALUES FOR CHANNELS

Compiled by
Guy B. Fasken, Drainage Engineer
SOIL CONSERVATION SERVICE - U. S. D. A.
Lincoln, Nebraska 68508
December 1963

UNITED STATES DEPARTMENT OF AGRICULTURE
SOIL CONSERVATION SERVICE
DECEMBER 1963

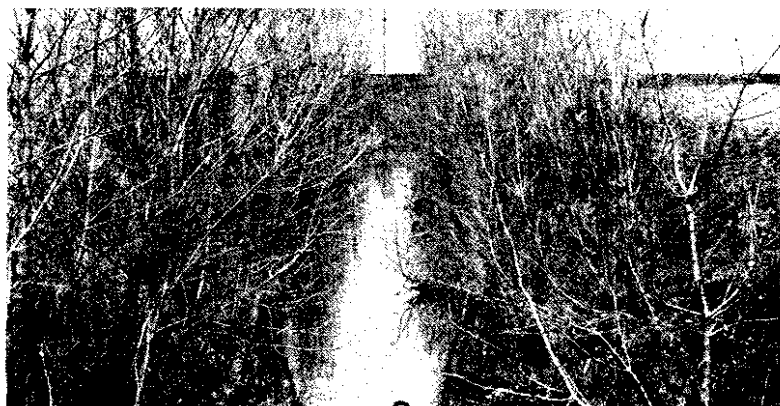
Kaskaskia Mutual Dredged Channel near Bondville, Illinois. Approximate bottom width 10 feet. Picture taken April 1925.

Date of observation	Average maximum depth	Average surface width	Discharge	Average cross section	Mean velocity	Mean hydraulic radius	Slope of water surface	Coefficient of roughness n	Description of channel
Feb. 7, 1925	2.1	16.5	21.9	24.6	0.89	1.36	0.000473	0.040	<i>Course</i> , straight; 330 feet long. <i>Cross section</i> , some variation in shape; for variation in size, see Figure 20, G. <i>Side slopes</i> , rather irregular. <i>Bottom</i> , rather irregular. <i>Soil</i> , lower part, black clay; upper part, dark-gray silty clay loam. <i>Condition</i> , badly obstructed by trees 1 to 6 inches in diameter on side slopes and edges of bottom; some weeds but practically no grass; no foliage. <i>Constructed</i> , 1902; cleared, about 1910. (Pl. 27, C and fig. 19, G.)
Mar. 16, 1925	3.0	18.9	45.5	39.6	1.15	1.89	.000424	.039	
Mar. 29, 1924	5.3	27.6	106.7	92.8	1.15	3.00	.000367	.051	
Feb. 25, 1926	5.7	29.6	100.7	105.7	.95	3.19	.000394	.067

Aug. 24, 1924	4.1	23.0	67.1	64.0	1.05	2.50	0.000494	0.056	<i>Condition</i> , as described above, but with summer foliage, and water weed on bottom along one-tenth of course.
June 6, 1924	4.4	24.1	72.2	71.9	1.00	2.66	.000409	.056	
do.	5.0	26.8	85.6	88.1	.97	2.95	.000373	.060	
Aug. 21, 1924	6.1	30.9	120.4	116.6	1.03	3.36	.000427	.067	
Aug. 20, 1924	8.4	41.0	206.1	200.3	1.03	4.35	.000536	.094

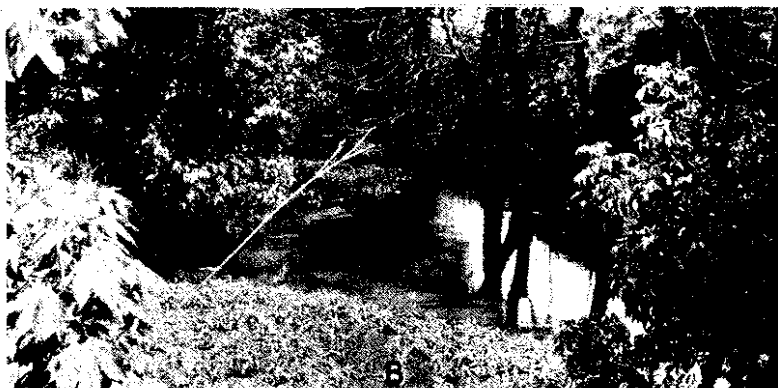
Kaskaskia Mutual Dredged Channel near Bondville, Illinois. Approximate bottom width 10 feet. Picture taken July 1927.

Condition, as in summer of 1924, but worse. (Pl. 27, B.)

Date of observation	Average maximum depth	Average surface width	Discharge	Average cross section	Mean velocity	Mean hydraulic radius	Slope of water surface	Coefficient of roughness n	Description of channel
Sept. 28, 1926	4.3	23.8	48.0	68.8	0.70	2.58	0.000645	0.097	<i>Course</i> , nearly straight; 330 feet long. <i>Cross section</i> , some variation in shape; for variation in size, see Figure 20, F. <i>Side slopes</i> , irregular. <i>Bottom</i> , irregular. <i>Soil</i> , lower part, black clay; upper part, dark-gray silty clay loam. <i>Condition</i> , badly obstructed by trees 2 to 12 inches in diameter covering side slopes, except intervals aggregating half length of right bank occupied by large weeds and bushy willows; no foliage. <i>Constructed</i> , 1902; cleared, about 1910.
Sept. 9, 1926	7.5	34.3	111.5	137.8	.71	4.05	.000388	.110	
Oct. 2, 1926	8.0	36.6	132.3	176.4	.75	4.24	.000409	.111	
do.	8.6	40.0	160.6	200.9	.80	4.43	.000421	.109

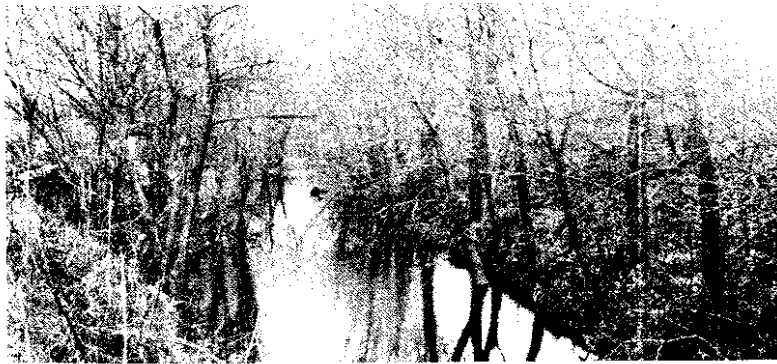
Kaskaskia Mutual Dredged Channel near Bondville, Illinois. Approximate bottom width 10 feet. Picture taken April 1925.

Date of observation	Average maximum depth	Average surface width	Discharge	Average cross section	Mean velocity	Mean hydraulic radius	Slope of water surface	Coefficient of roughness n	Description of channel
Feb. 7, 1925	2.4	18.1	21.9	29.8	0.73	1.50	0.000527	0.054	<i>Course</i> , nearly straight; 330 feet long. <i>Cross section</i> , some variation in shape; for variation in size, see Figure 20, F. <i>Side slopes</i> , irregular. <i>Bottom</i> , irregular. <i>Soil</i> , lower part, black clay; upper part, dark-gray silty clay loam. <i>Condition</i> , badly obstructed by trees 2 to 12 inches in diameter covering side slopes, except intervals aggregating half length of right bank occupied by large weeds and bushy willows; no foliage. <i>Constructed</i> , 1902; cleared, about 1910. (Pl. 27, A and fig. 19, F.)
Mar. 16, 1925	3.3	19.8	45.5	46.1	.99	2.09	.000503	.052	
Feb. 25, 1926	6.1	29.3	100.7	114.5	.88	3.44	.000397	.077

Aug. 8, 1924	4.4	24.0	67.1	71.0	0.95	2.60	0.000591	0.070	<i>Condition</i> , as described above, but with summer foliage, and three-fourths of length of bottom covered with short weeds.
June 6, 1924	4.8	25.1	72.2	79.9	.90	2.82	.000500	.072	
do.	5.4	26.9	85.6	96.5	.89	3.15	.000424	.074	
Aug. 21, 1924	6.4	30.5	120.4	124.8	.96	3.60	.000473	.080	
Aug. 20, 1924	8.8	40.8	206.1	207.4	.99	4.49	.000503	.097

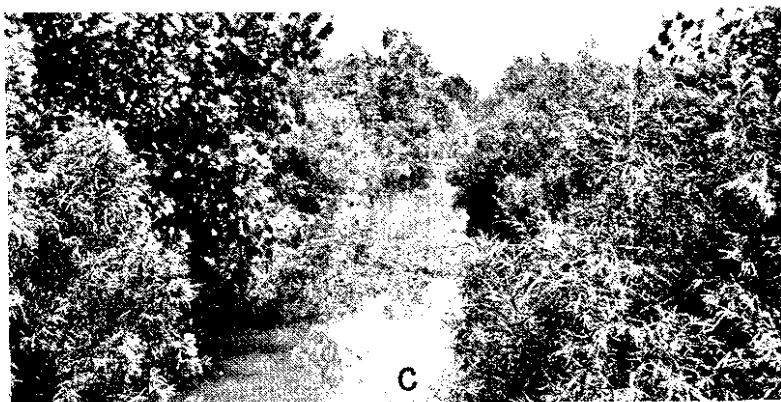
Condition, side slopes covered with heavy growth of poplar trees 2 to 3 inches in diameter, large willows, and climbing vines; thick growth of water weed on bottom. (Pl. 29, C.)

Date of observation	Average maximum depth	Average surface width	Discharge	Average cross section	Mean velocity	Mean hydraulic radius	Slope of water surface	Coefficient of roughness n	Description of channel
Sept. 10, 1926	Feet 4.6	Feet 28.6	Second-feet 60.9	Sq. ft. 87.9	Ft. per sec. 0.69	Feet 2.84	0.000516	0.095	<i>Course, straight; 661 feet long. Cross section, very little variation in shape; for variation in size, see fig. 20, J. Side slopes, fairly regular. Bottom, uneven and irregular. Soil, lower part, yellowish gray clay; upper part, light gray silty clay loam. Condition, in 1924, newly cleaned leaving weeds and stubble on side slopes; in 1926, sides covered with trees and vines without foliage. Constructed, 1906; cleaned, winter of 1923-24.</i>
Oct. 2, 1926	7.3	36.0	164.9	175.7	.94	4.37	.000546	.104	
	18.5

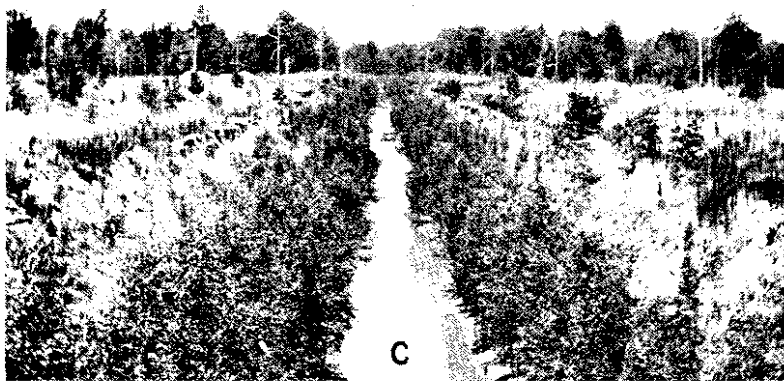
13.5								
1 Average maximum depth at bankful stage.									Course, same as above. Condition, practically the same, except that willows and other vegetation are in full foliage. (Pl. 18, C.)

Date of observation	Average maximum depth	Average surface width	Discharge	Average cross section	Mean velocity	Mean hydraulic radius	Slope of water surface	Coefficient of roughness n	Description of channel
May 12, 1926	4.0	41.8	55.9	104.5	0.53	2.41	0.000273	0.078	Course, straight; 710 feet long. Cross section, very little variation in shape; for variation in size, see fig. 15, E. Side slopes, fairly regular. Bottom, fairly regular. Soil, upper, sandy loam; lower, silty clay. Condition, growth of willows in channel 6 to 10 feet high except on upper part of side slopes and narrow strip of channel. willows about one year old. Constructed summer 1924
Nov. 11, 1926	7.1	57.8	314.1	262.6	1.20	4.34	.000390	.068	
Nov. 7, 1926	8.4	61.1	410.7	338.8	1.21	5.22	.000315	.070
